An Taisce
The National Trust for Ireland

Buildings at Risk

November 2014

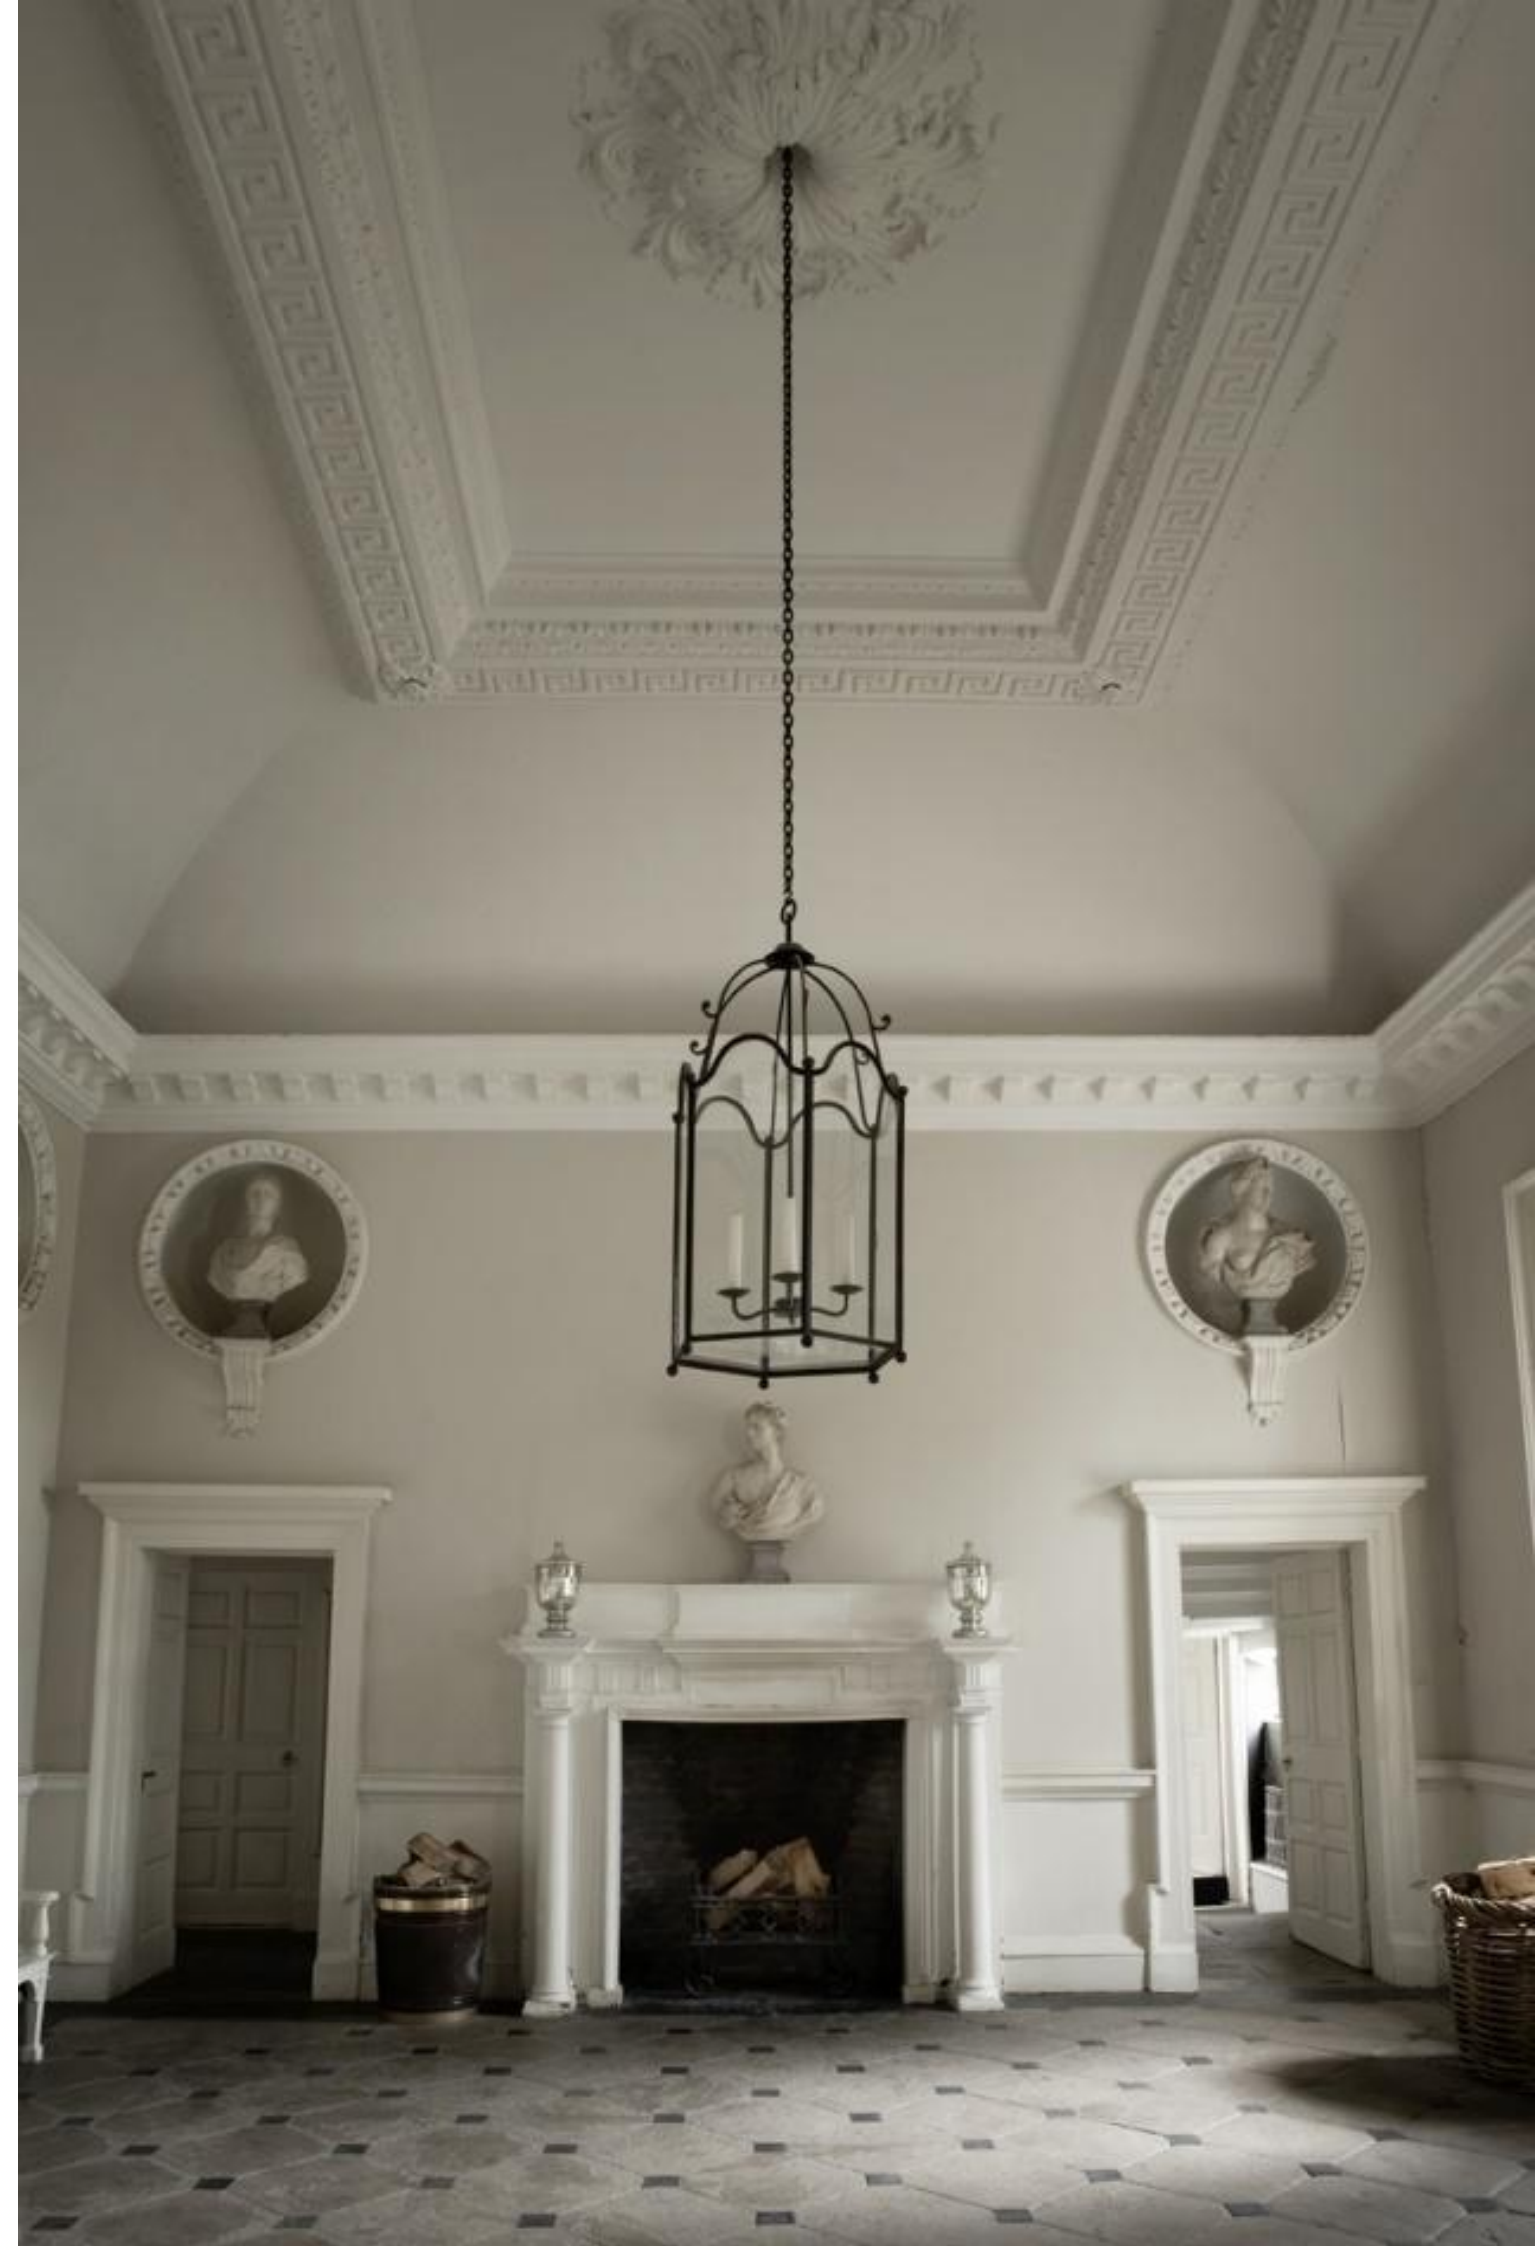
This building has been vacant for a number of years and does not appear to be maintained. Most of the external fabric remains, but there are obvious signs of deterioration, particularly water penetration. There is no immediate danger of collapse but the condition is such that unless urgent remedial works are carried out the building will sharply deteriorate.

The building was designed by Sir Edward Lovett Pearce and inspired by Palladian Italian villas. Lovett Pearce was also the architect of Parliament House on College Green in Dublin. The classical busts (pictured) original to building have been removed from the entrance hall. This building urgently requires new uses to be identified to prevent integral features being gradually lost.

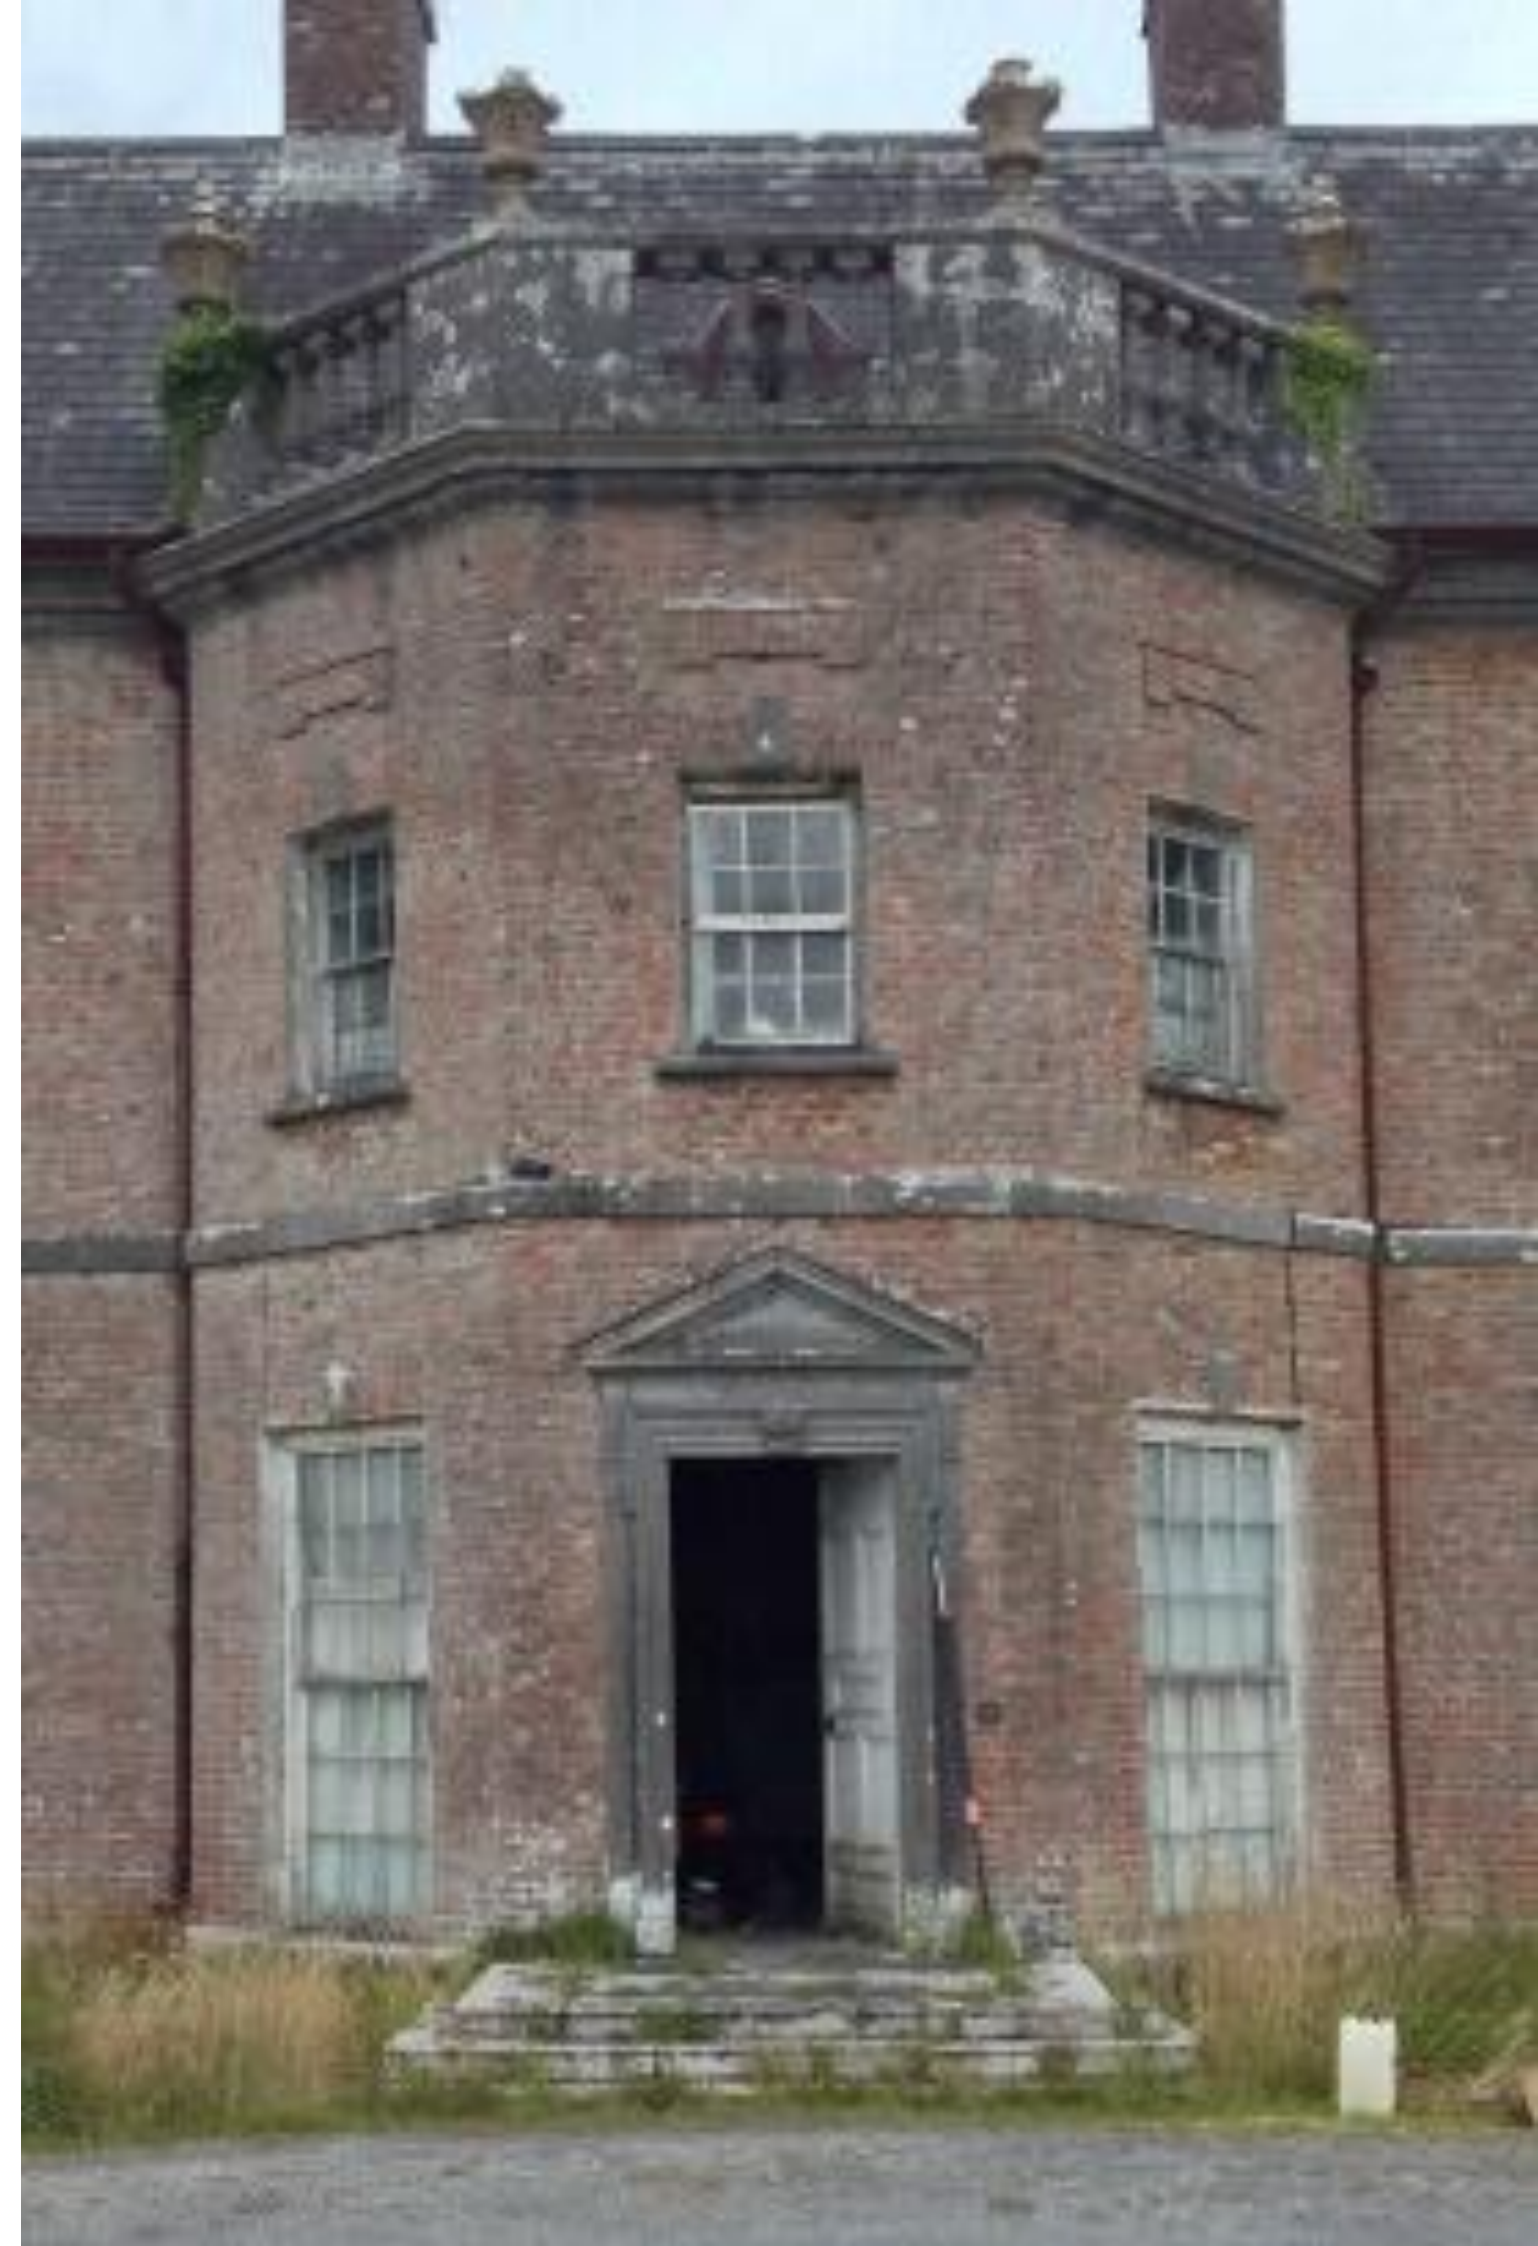
This building has been vacant for a number of years and does not appear to be maintained. Most of the external fabric remains, but there are obvious signs of deterioration, particularly water penetration and broken windows. There is no immediate danger of collapse but the condition is such that unless urgent remedial works are carried out the building will sharply deteriorate.

Newhall is a late 17th century house with a mid 18th century red block added with bowed ends. It has fine interior detailing including a cupboard in entrance hall disguised as an organ case. The house is currently vacant and for sale. This building urgently requires new uses to be identified to prevent further deterioration of its character.

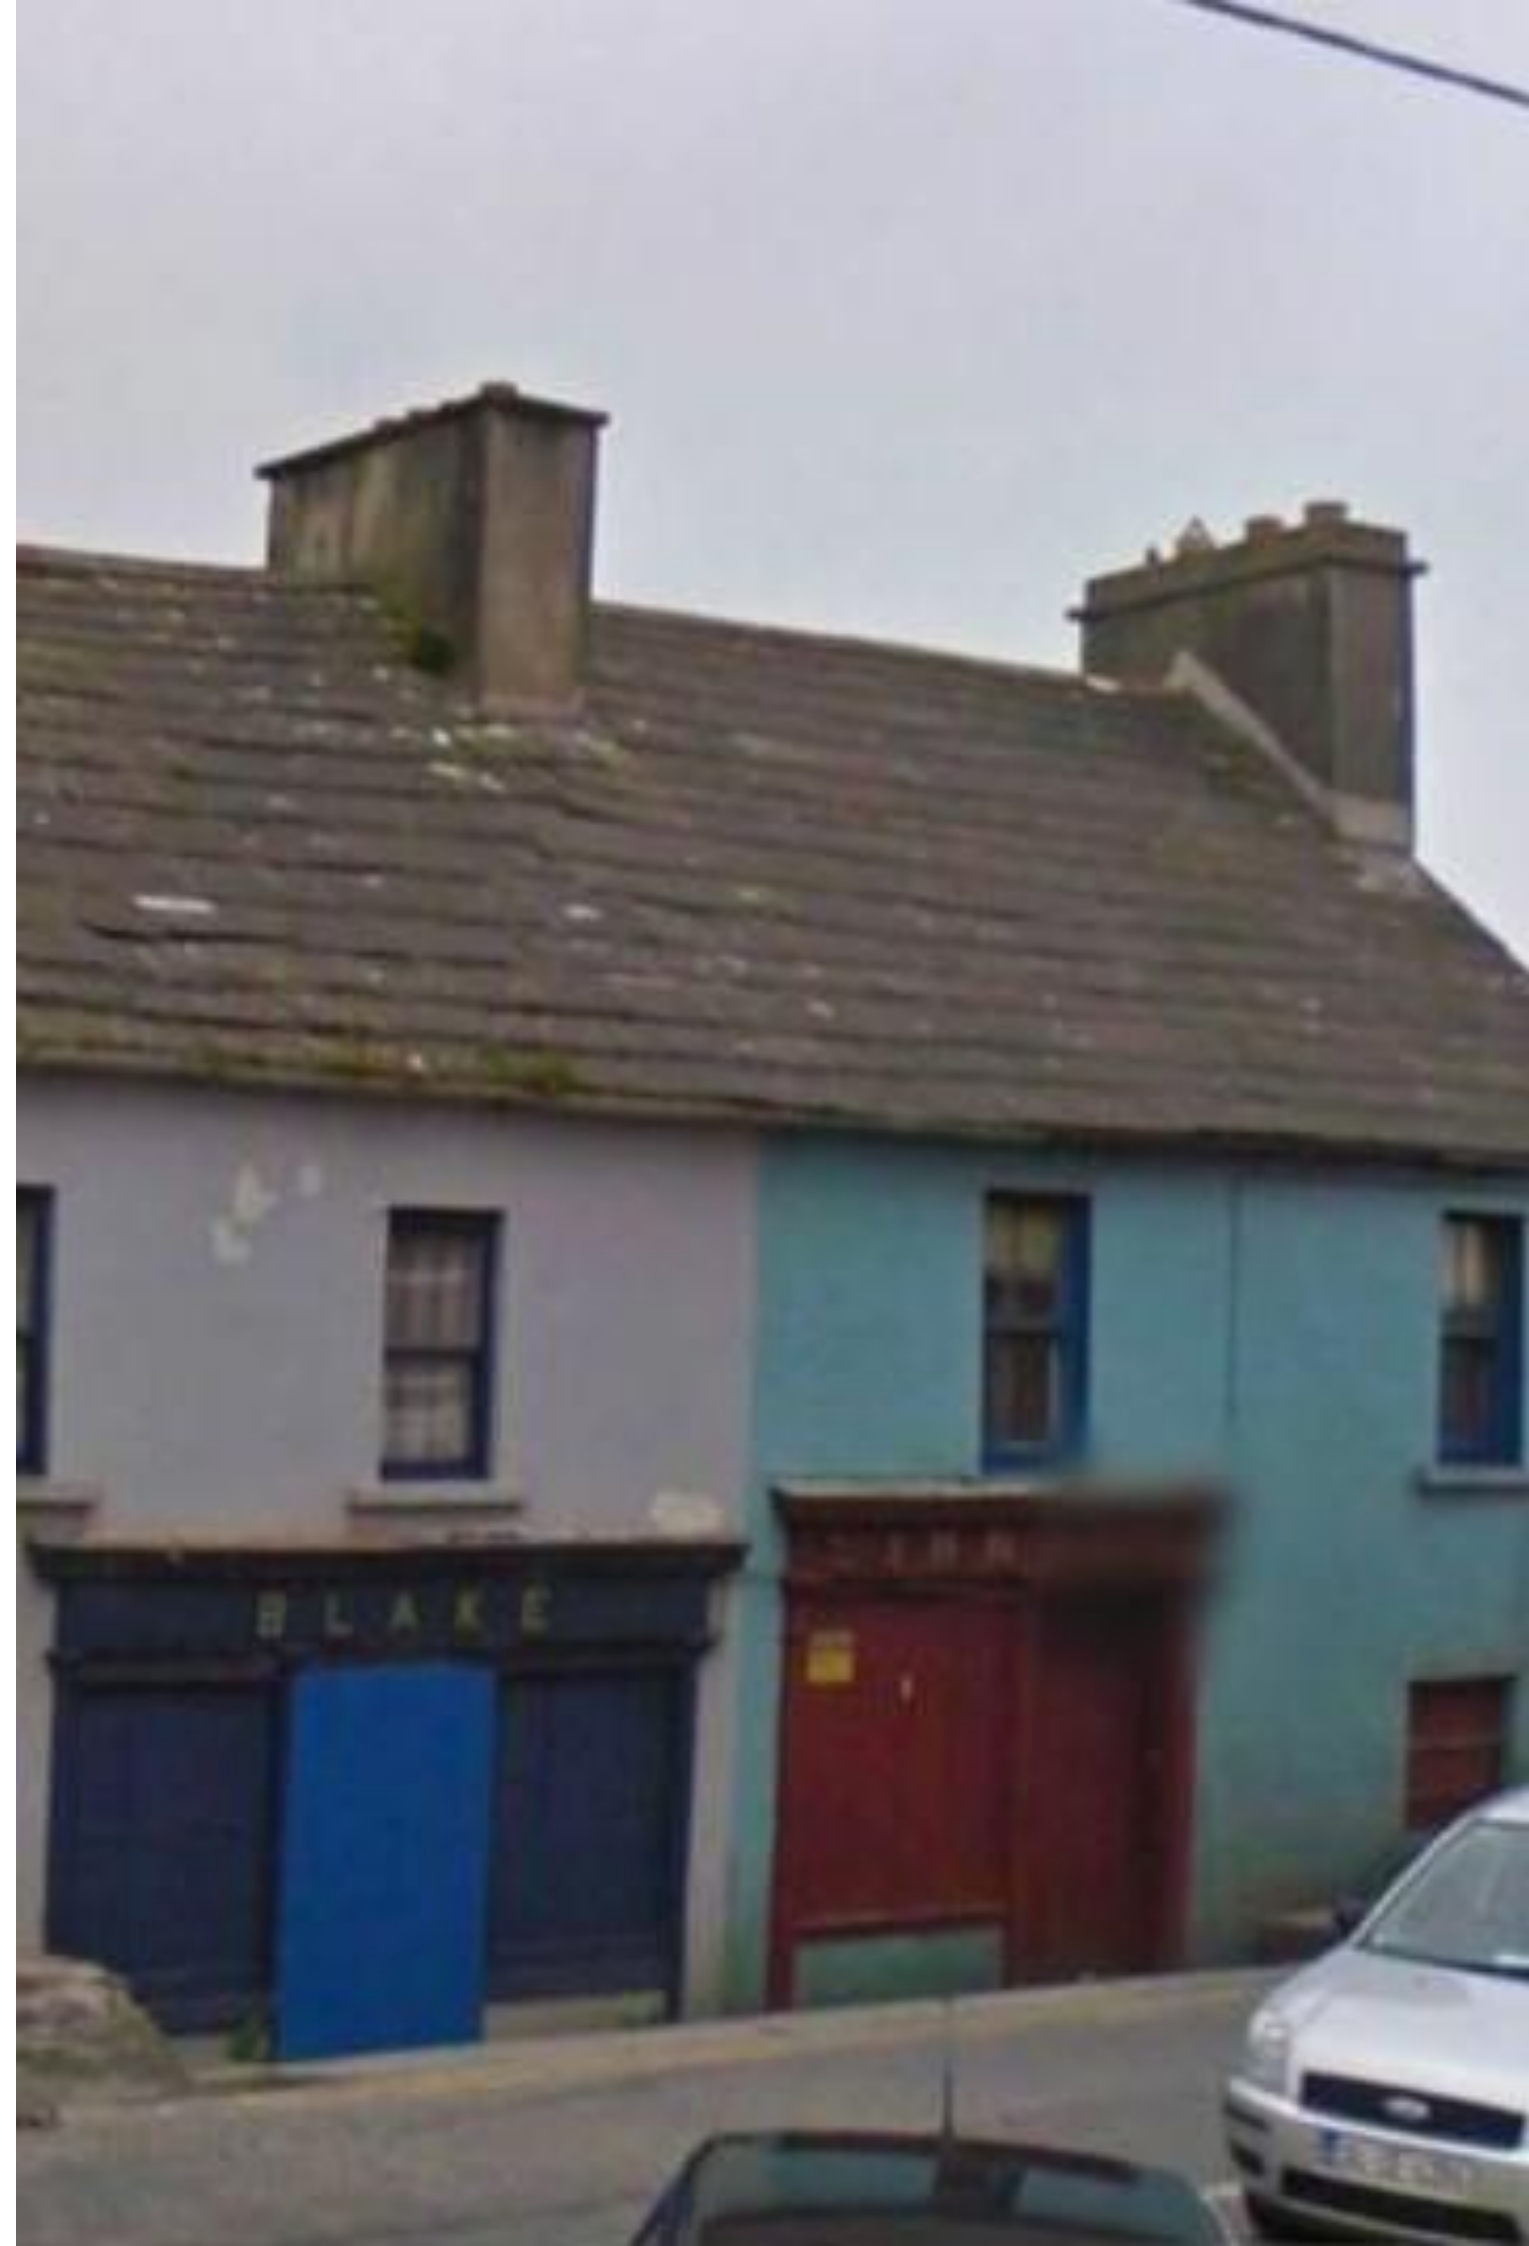
This building has been vacant for a number of years and does not appear to be maintained. Most of the external fabric remains, but there are obvious signs of deterioration, particularly water penetration, slipped slates, vegetation growth, broken windows and vandalism. The building is threatened with demolition.

Clare County Council has plans to demolish Blake and Linnane's to allow for a roundabout. The aim of this controversial scheme is to regulate summertime tourist traffic. The pair of mid 19th century shop buildings are located alongside the narrow bridge. Both buildings are protected structures because of the quality of their original shop fronts, Liscannor-slatted roofs and overall proportions. These buildings need to be retained with new uses identified.

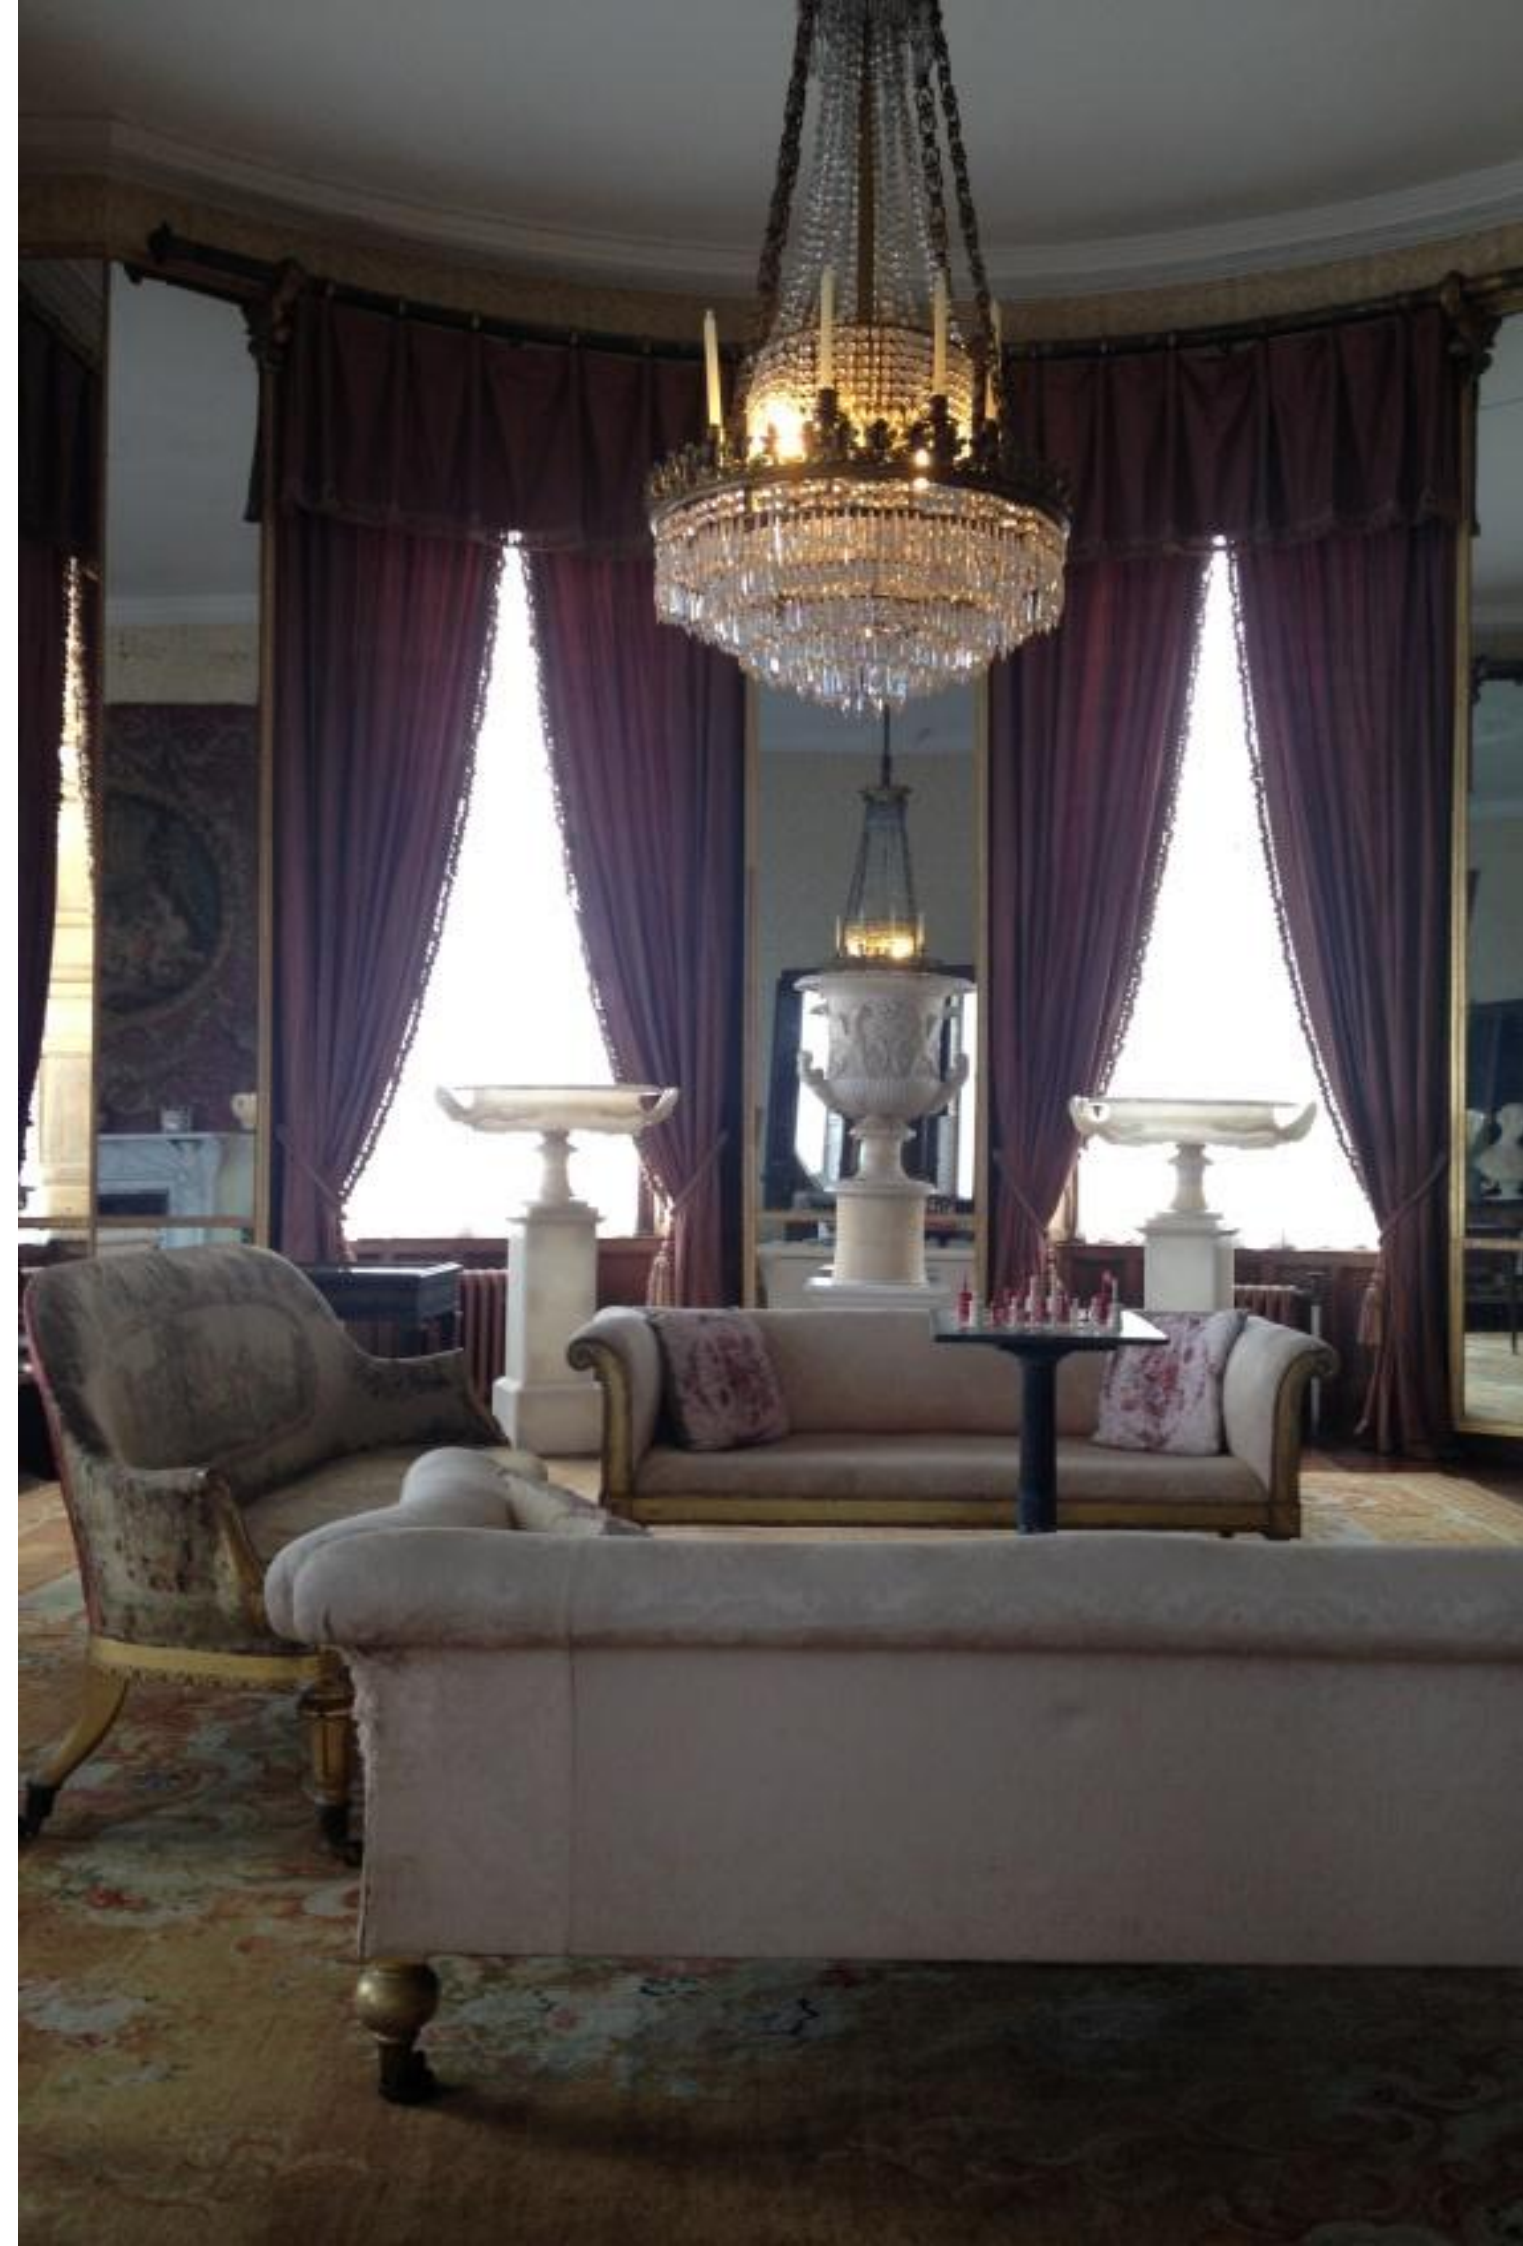
The fabric of this building is generally sound, and its overall condition does not necessarily place it at risk. However, it is under threat of losing integral internal features, such as furniture, which places its future sustained use in doubt.

Its interiors which are much visited and photographed are distinguished by the remaining part of the major collection of furniture, tapestries, busts, portraits, tableware and other objects collected by the Second Earl in the mid 19th century from his travels across Europe. In order to raise funds to secure the future of the house the family announced that the main remaining historic contents were to put up for sale by Scottish auctioneers Lyon and Turnbull on October 21st 2014, with a €1.5m to €1.7m estimate. On 18th September 2014 it was announced that the auction is to be deferred. This allows alternative plan to be put in place to retain the historic contents. An initiative is required by which the main historic contents of Bantry House, which are threatened with sale, are acquired by an appropriate cultural institution for the Nation.

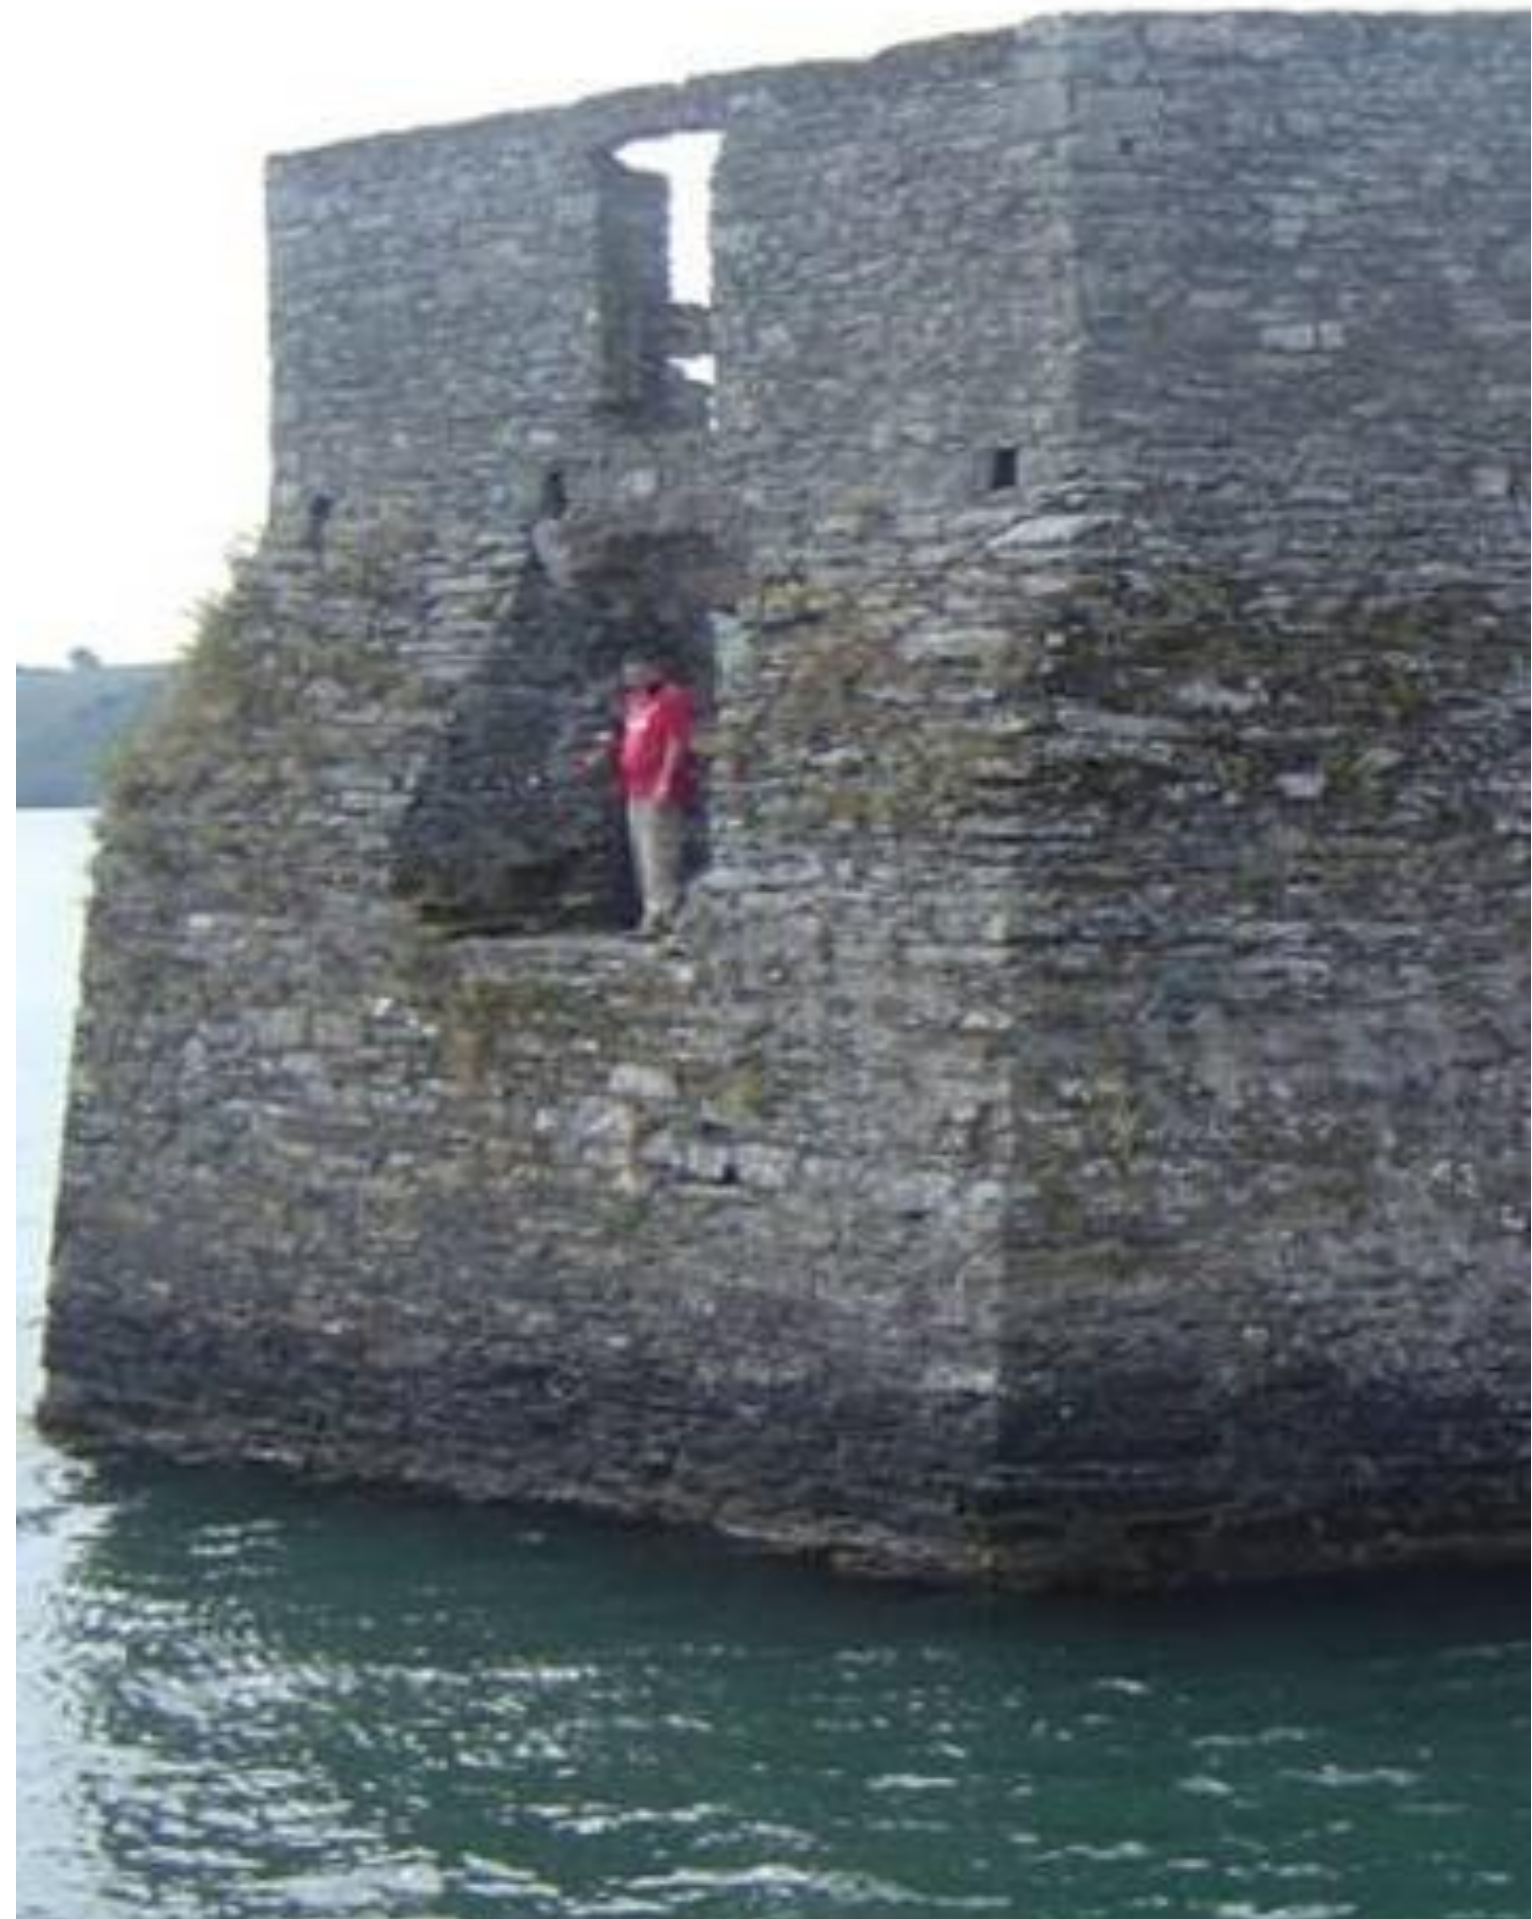
Dating from the 16th century with later alterations, it formed part of the defence of Kinsale Harbour together with James Fort and Charles Fort, located to the south-east. Significant conservation is required to prevent further deterioration of the structure which is constructed on a rock outcrop. The fortifications in Kinsale Harbour have the potential to become a large draw for tourism in the area.

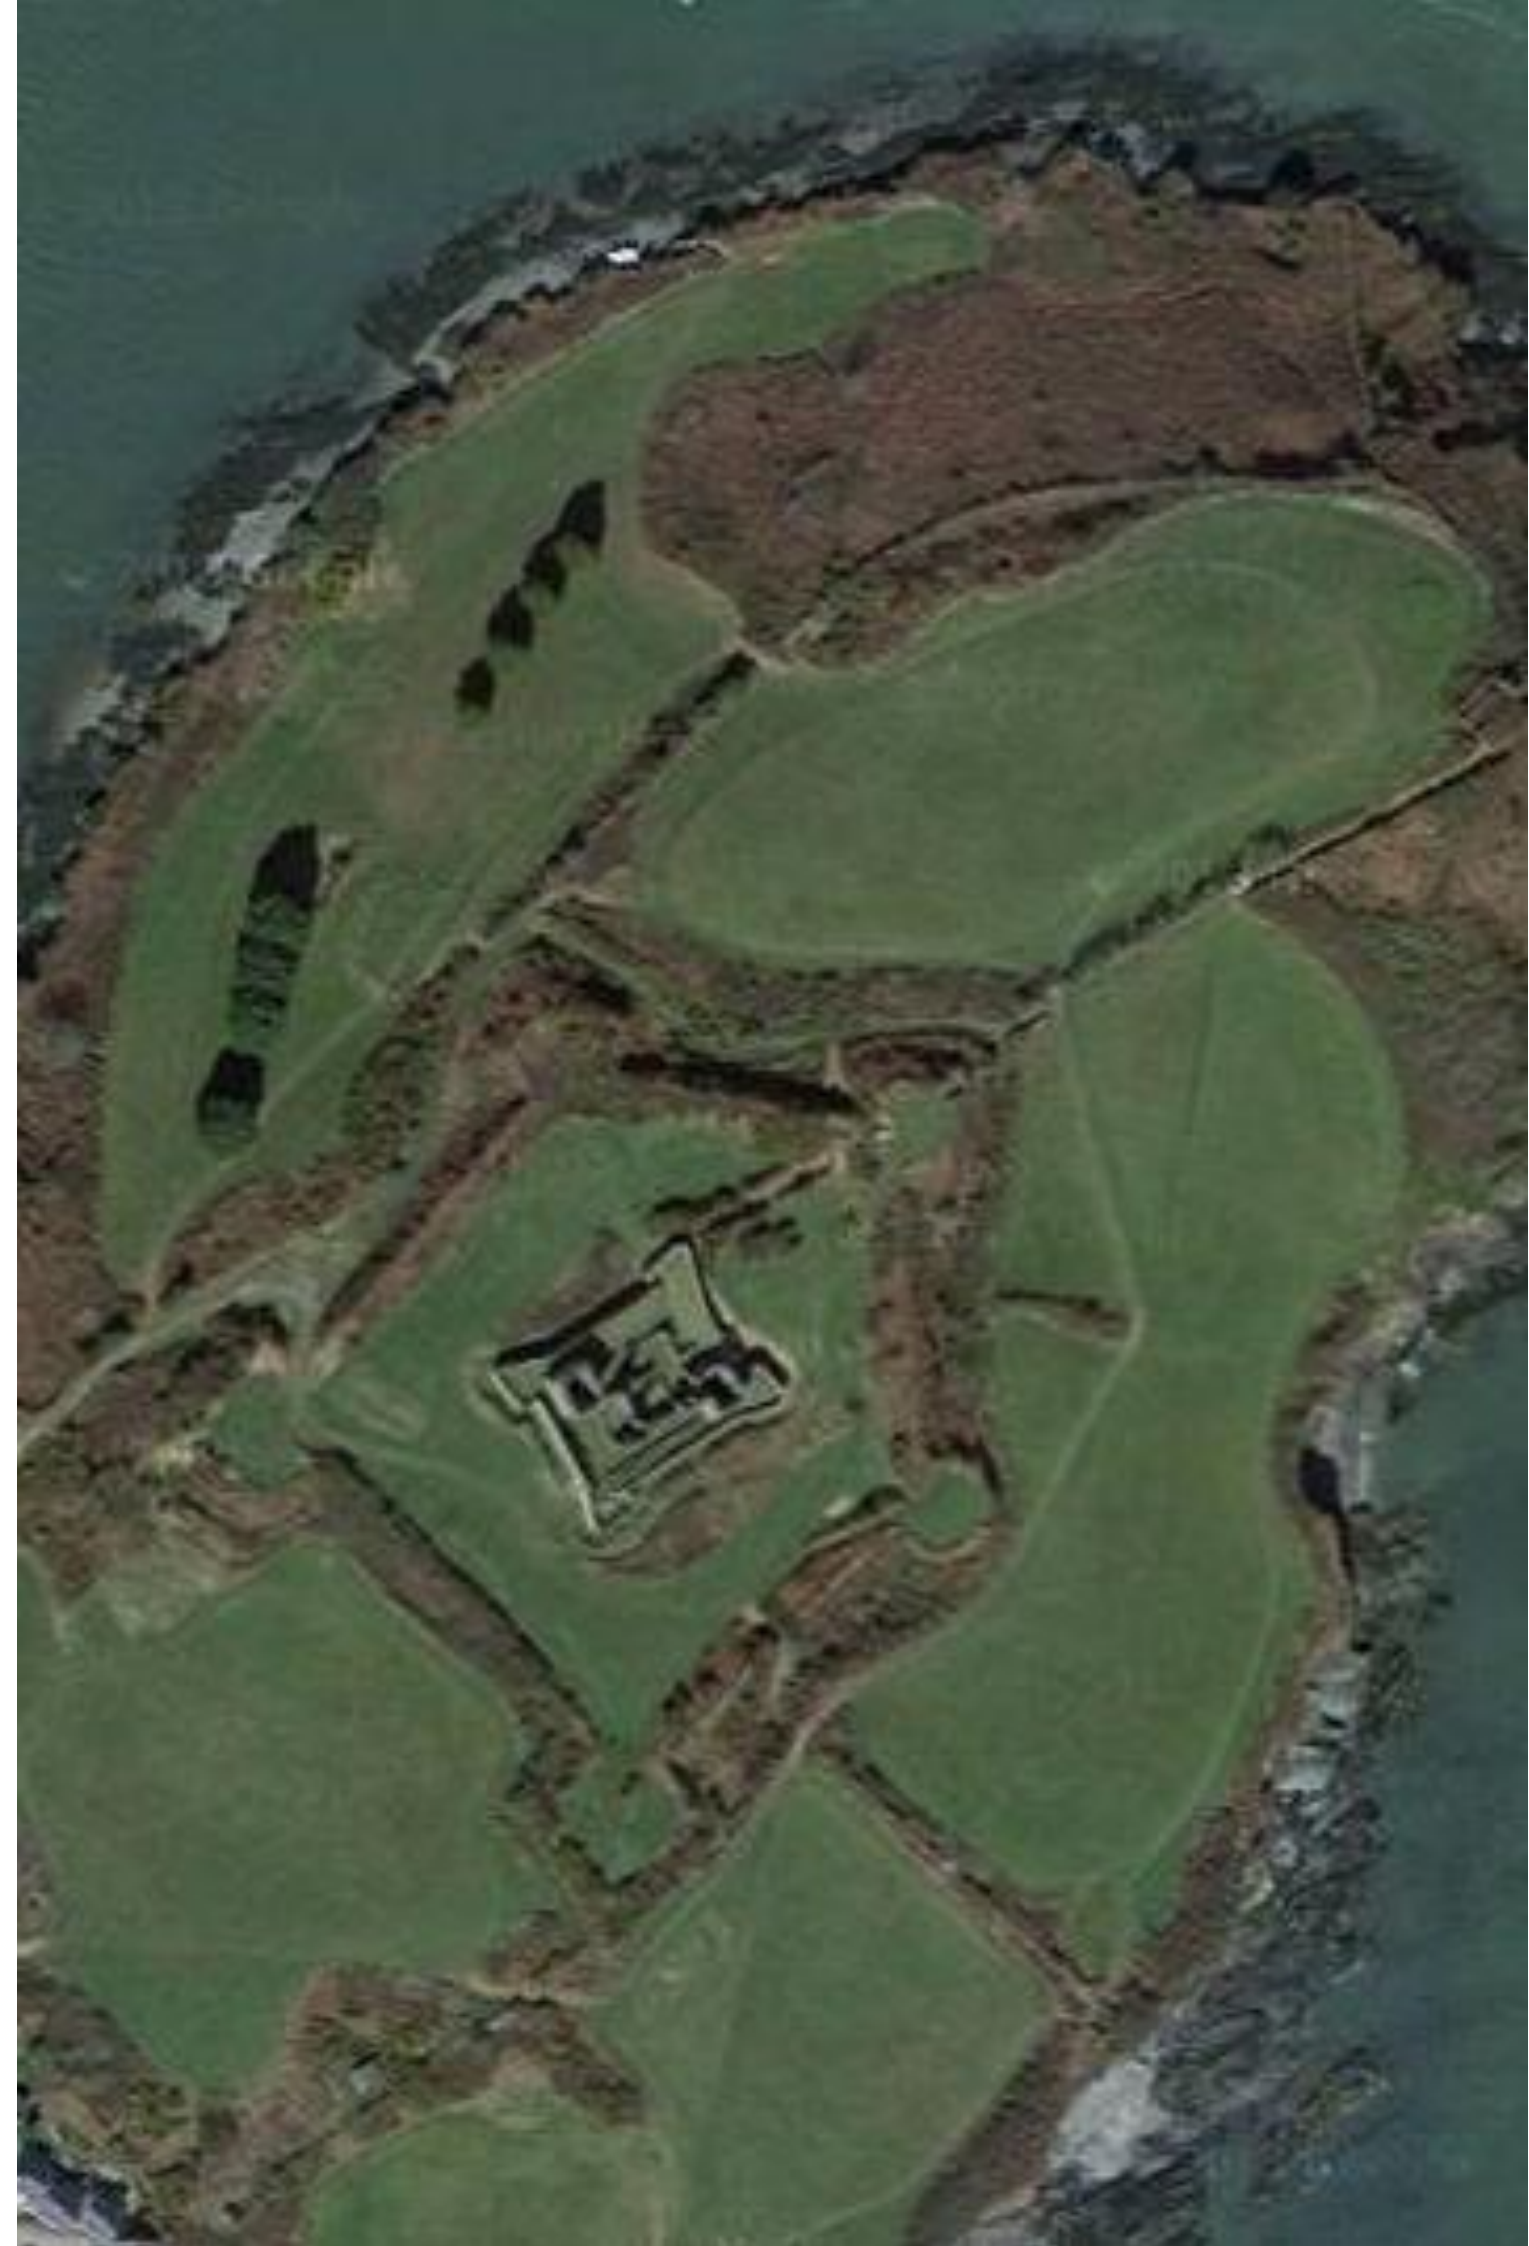
Dating from the early 17th century, the fort was designed to protect Kinsale Harbour from the west opposite Charles Fort to the east. The structure has received conservation work required to prevent further deterioration. However, it requires a long-term conservation management plan to prevent future deterioration. The fortifications in Kinsale Harbour have the potential to become a large draw for tourism in the area.
